Depreciation Report Update | Project R-03577.032 The Lions, 1331 & 1367 Alberni Street, Vancouver, BC

To: The Owners, Strata Plan LMS3942 c/o Jeff Wolrige, Property Manager Southview Property Management Inc. #110 - 7580 River Road Richmond BC V6X 1X6 Site Visits: October 29, 2021 and November 15, 2021 Submitted: June 7, 2022 by RDH Building Science Inc. 4333 Still Creek Drive #400 Burnaby BC V5C 6S6

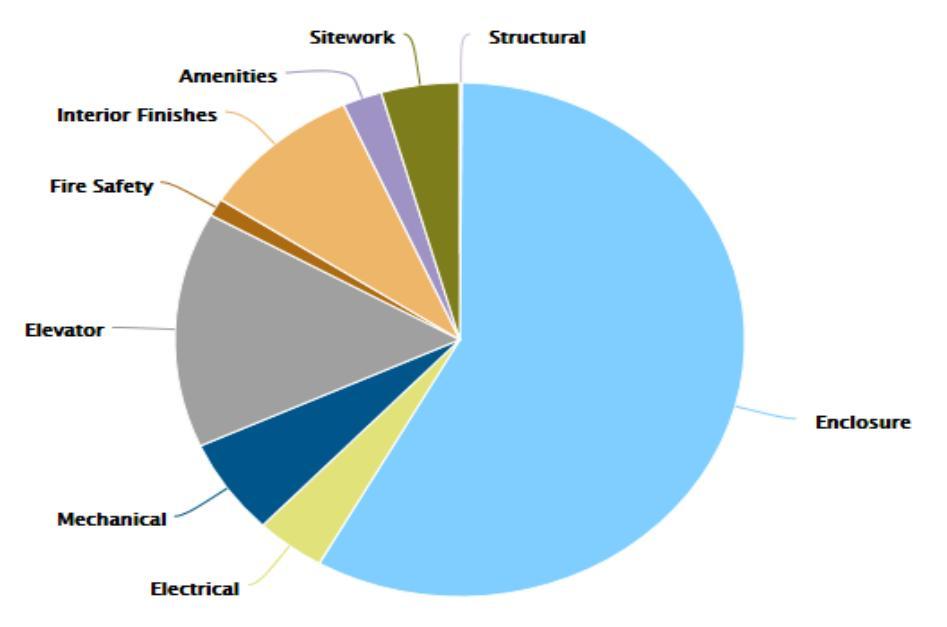
Figure 4.1 Distribution of estimated capital expenditures over 10 years by system.

Approximately 20% of the Strata Corporation's capital expenditures may occur in the next 10 years. The distribution of estimated capital expenditures over the next 10 years is shown in Figure 4.1 below.

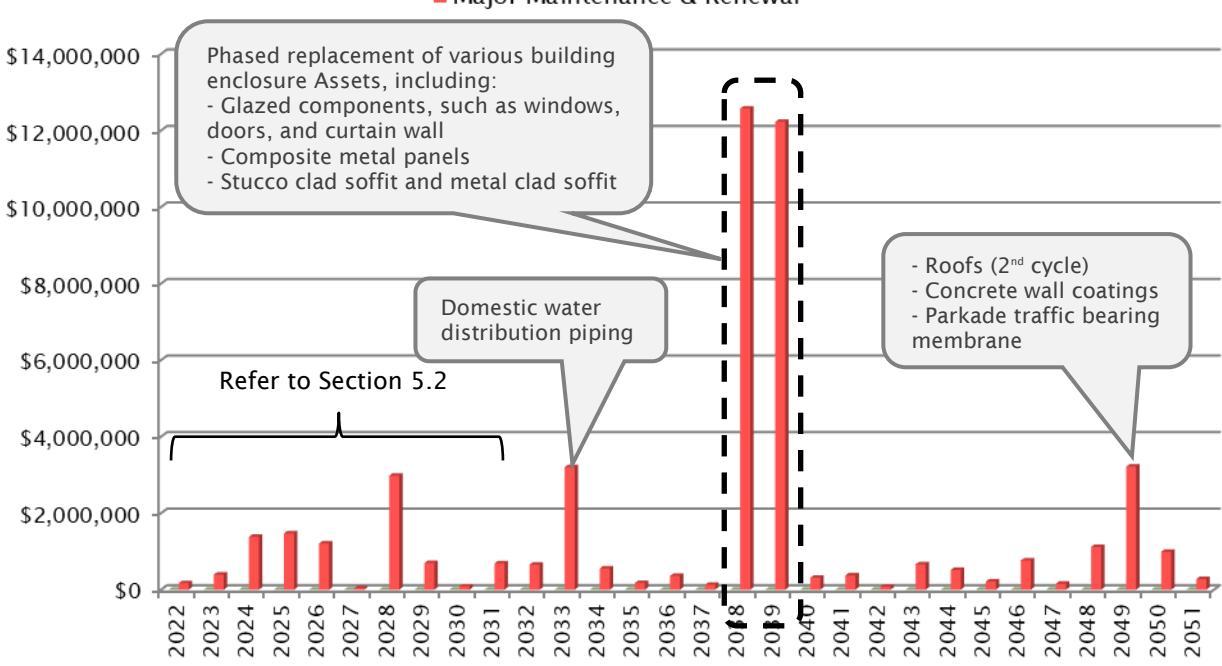
Figure 5.1 Strategic Forecast (30 Years), showing the approximate timing and value of some key capital expenditures.

Estimated major maintenance and renewal costs over the next 30 years are shown on the graph below (Figure 5.1). The red bars represent the estimated value of capital costs.

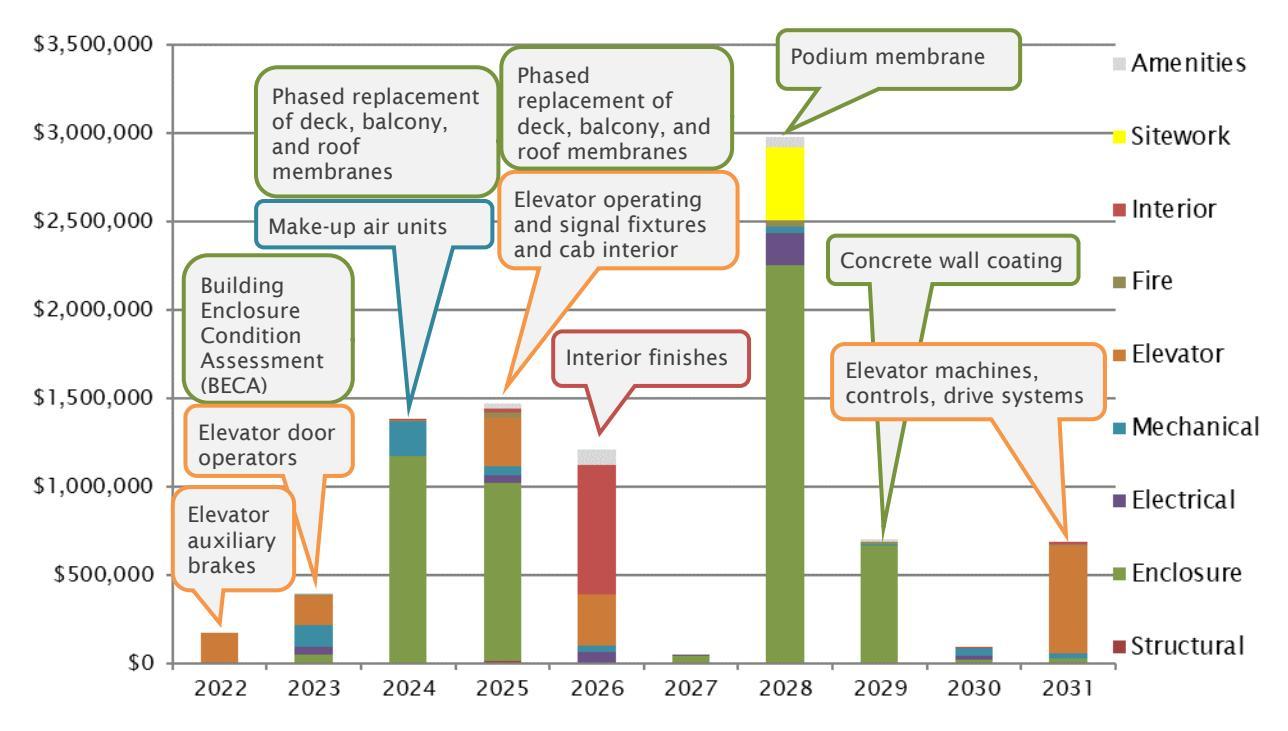
Figure 5.2 Tactical Forecast (10 years), showing the approximate timing and value of some key capital expenditures.

The bars indicate the years in which an event (or bundle of events) is most likely to occur, as well as the total magnitude of major maintenance and renewal costs for that year and the costs broken down by system. The soft costs associated with project implementation, such as site access, design, and contract administration are not included.

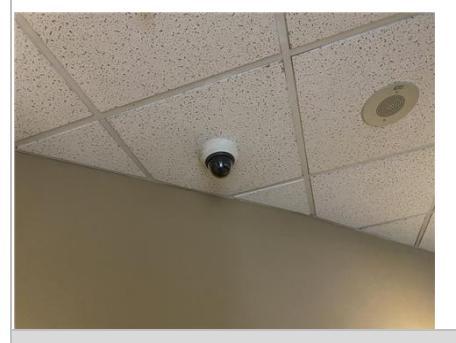
Elec 09 - Security Surveillance

Location	Information	
Throughout common areas.	Service Life:	14
Description	Installed Year:	1998
Cameras, multiplexer, monitors and storage	Chronological Age:	24
media to deter and track activity on and	Effective Age:	13
within building premises.	Next Renewal Year:	2023

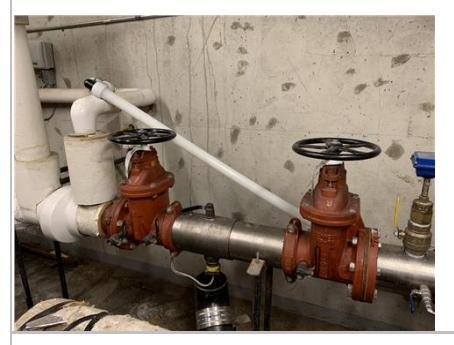
Mech 22 - Valves - Backflow Prevention - Main Domestic Service

Location	
Water Entry room.	
Description	
Various types and sizes of backflow	
prevention valves.

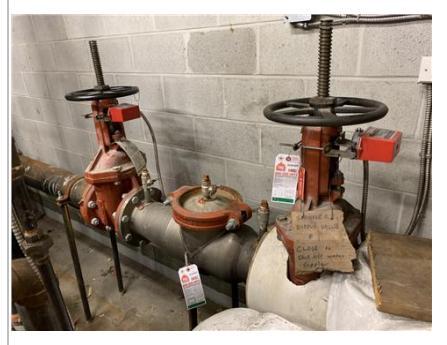
Mech 24 - Valves - Plumbing Flow Control and Directional

Location	Information	
Water entry room.	Service Life:	20
Description	Installed Year:	199
Various types and sizes of valves, including	Chronological Age:	24
pressure reducing valves, isolation valves,	Effective Age:	17
two-way and three way valves, circuit flow control valves and check valves to regulate	Next Renewal Year:	202
the flow of water through domestic		
plumbing systems. PRV valves repairs done		
in 2020.

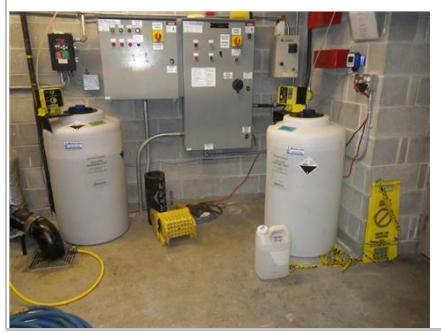
Mech 25 - Water Treatment Equipment - Water Conditioner [PLACEHOLDER]

Location	Information	
Location	Information	
Water entry room.	Service Life:	8
Description	Installed Year:	2008
1ClearWater treatment tanks, filters,	Chronological Age:	14
chemical dosers, metering pumps and	Effective Age:	10
other associated equipment to provide treatment for potable water system. This	Next Renewal Year:	2020
asset is leased from 1Clearwater.

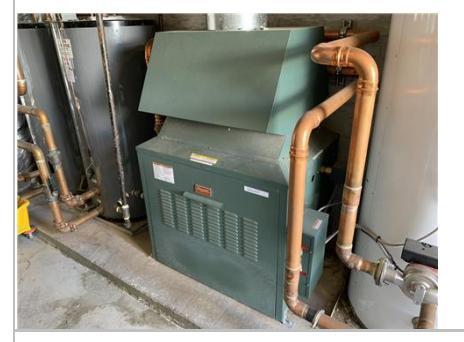
Mech 26 - Boiler - DHW - Heating - Gas Fired - [East - B1]

Location	Information	
Rooftop mechanical room at east building.	Service Life:	14
Description	Installed Year:	2019
Raypak, coppertube natural gas fired,	Chronological Age:	3
domestic service hot water heater,	Effective Age:	3
Water heaters are connected to glass lined storage tanks.	Next Renewal Year:	2033

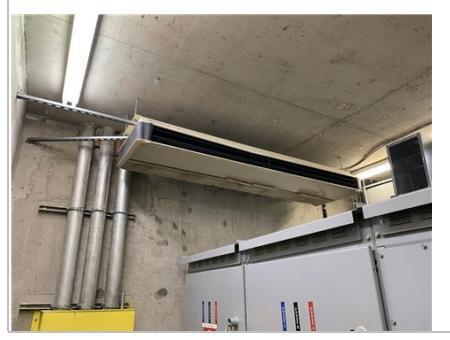
Mech 33 - Fan Coil Unit [2013]

Location	Information	
Throughout P1.	Service Life:	15
Description	Installed Year:	2019
Condensing units, associated indoor fan coil	Chronological Age:	3
units for air conditioning.	Effective Age:	3
	Next Renewal Year:	2034

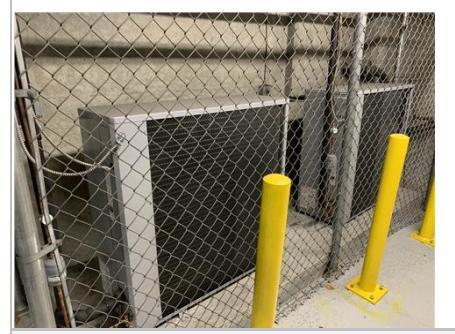
Mech 34 - Condensing Unit - Outdoor Section - AC Cooling only [2020]

Location	Information	
Throughout parkade.	Service Life:	15
Description	Installed Year:	2020
Carrier, condensing units with associated	Chronological Age:	2
ceiling mounted indoor fan coil units for air	Effective Age:	2
conditioning (cooling only).	Next Renewal Year:	2035

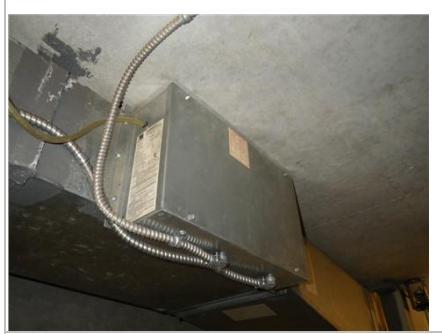
Mech 35 - Coil - Electric - Duct Heater

Location	Information	
Mens change room, parkade Levels P1 and	Service Life:	17
P2.	Installed Year:	1998
Description	Chronological Age:	24
10-42 KW, electric duct heaters, duct-	Effective Age:	16
mounted with clements.	Next Renewal Year:	2023

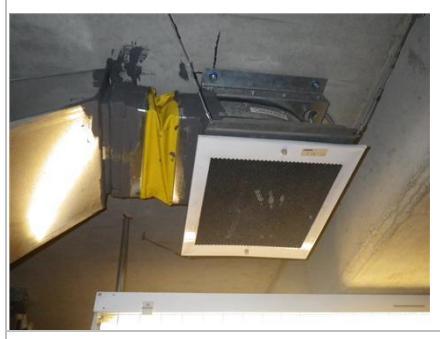
Mech 38 - Exhaust Fan - Small Service - Cabinet

Location	Information		
Service rooms	Service Life:	12	
Description	Installed Year:	1998	
Direct drive fans, ceiling and cabinet fans,	Chronological Age:	24	
and centrifugal inline blower fans.	Effective Age:	10	
	Next Renewal Year:	2024

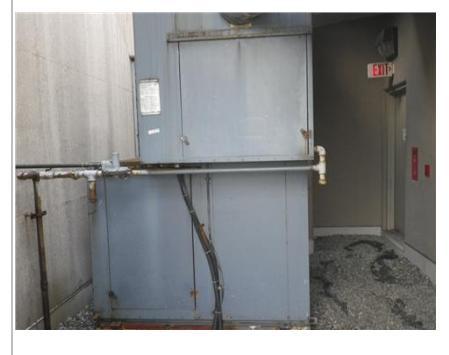
Mech 40 - Outdoor Air Handler - Makeup Air - Gas [East Building]

Location	Informa
Main low-sloped roof of east building.	Service
Description	Installe
Engineered Air DJ-100, 10,400 CFM outdoor rooftop unit, belt-driven, centrifugal fan with natural gas fired heating to supply tempered make-up air to the interior	Chrono Effectiv Next Re
567,000 btuh output. Localized repairs and	
replacements completed in an as-needed

- → Jetflush or auger drainage piping Assets and insert video cameras into the main lines to conduct pipe inspection (on a 5-year cycle). Some affected Assets include:
 - → Mech 09 Sanitary Drainage
 - → Mech 16 Perimeter and Foundation Drainage
 - → Mech 17 Storm Drainage
- \rightarrow Mech 40 and Mech 41 Outdoor Air Handler Rebuild or replacement of make-up air units.

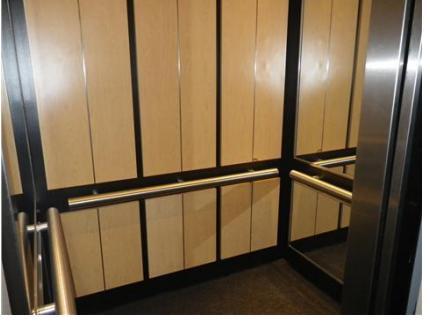
Elev 02 - Elevator Cabs & Hoistway (6)

-		
	Location	Information
	Elevator cab and travelling hoistway.	Service Life:
	Description	Installed Year:
	Single speed side opening doors, plastic car and hall pushbuttons, one (1) car operating	Chronological Age:
		Effective Age:
	panel (stainless steel), infrared door protection ECI-1000 door operators	Next Renewal Year
	stainless steel doors and front return,	
	mirror with painted steel reveals on side	
	walls, plastic laminate on rear wall, mirror	
	ceiling, carpet flooring, tubular stainless	
	steel handrails on all non-access walls,	
	firefighter's emergency operation, standby	
	power provisions, hands-free voice	
	communication devices, no seismic	
	provisions.

- → Elev 01 Traction Elevators As per the recommendation of the Elevator Assessment Report and Capital Budget Plan dated January, 2022 by TK Elevator (Canada) Ltd., plan for replacement of auxiliary brakes 'Sheave Jammers' with Rope Grippers.
- → Elev 02 Elevator Cabs & Hoistway Phased replacement of door operators, fixtures, and cab interiors.

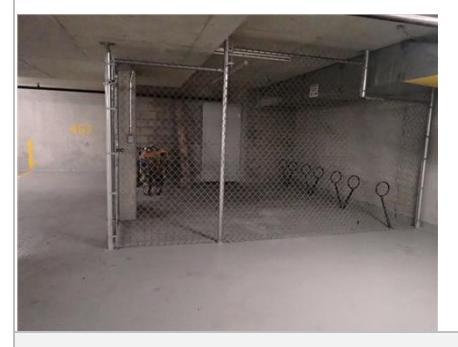
Amen 05 - Chainlink fencing

Location	Informat
Bicycle storage rooms in parkade.	Service L
Description	Installed
Woven fence made from coated steel wire	Chronolo
and galvanized steel posts.	Effective
	Next Rer

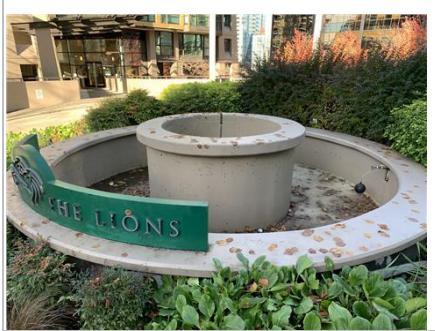
Site 03 - Water Feature

Location
Driveway adjacent to Alberni St.
Description
Ponds and channels to retain water
including liner.

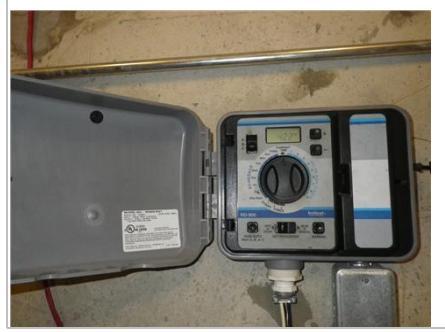
Site 06 - Irrigation System

Location	Information	
Water entry room	Service Life:	15
Description	Installed Year:	2012
Irritrol RD-900 controller with time clock,	Chronological Age:	10
network of pipes, valves, and irrigation	Effective Age:	9
landscaping. Two irrigation controllers were	Next Renewal Year:	2028
replaced in 2012.
